# Dacre Banks, Culvert Investigation

## Site Background

## Site investigation

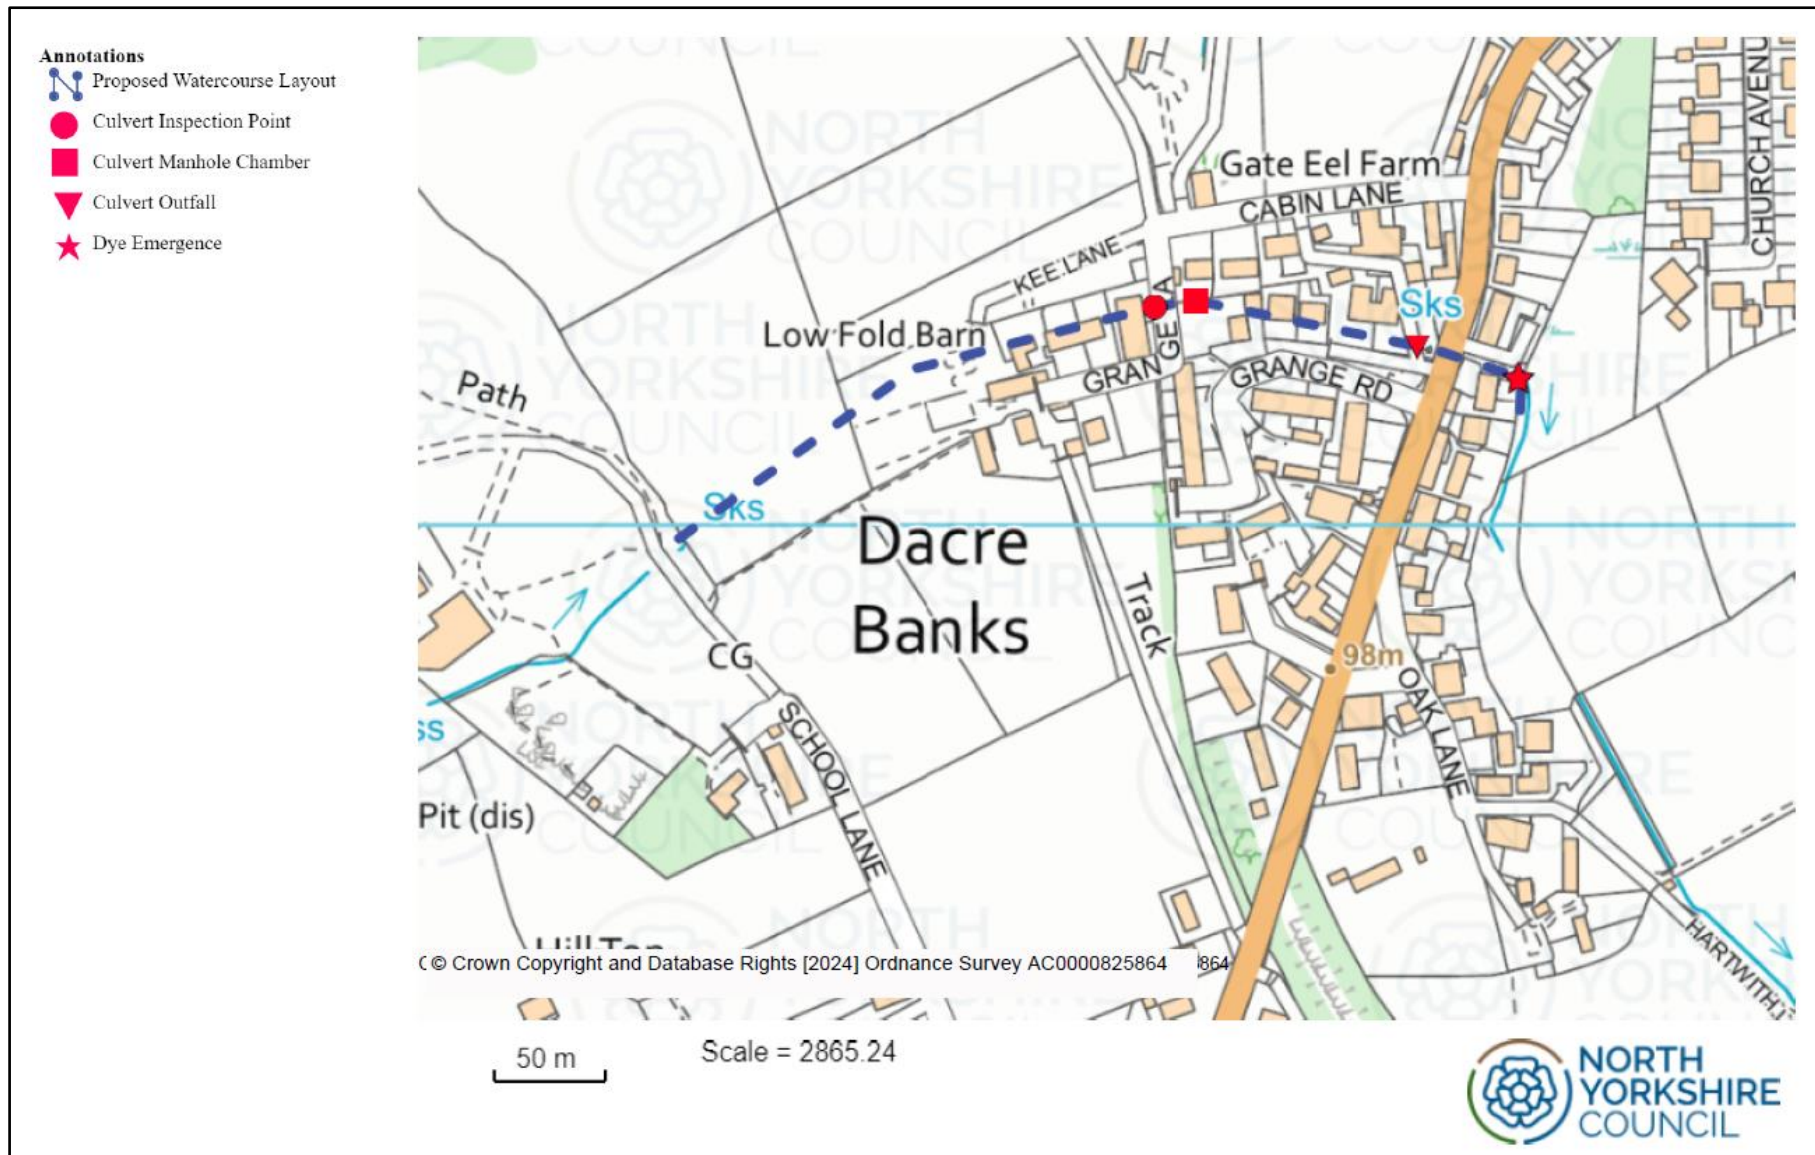
**Map 1: Suggested location of culverted watercourse from Grange Lane in Dacre Banks**

North Yorkshire Council Highways Officers undertook a site visit on 15th July 2024. The officers originally attempted to access the culvert within the inspection point between “The Alamo” property and Grange Lane (red circle on Map 1). From here it was identified via camera survey that the culvert is an old stone culvert, the camera did not get far downstream into the culvert, as there was a culvert stone that was partially blocking the path. Whilst there is a dislodged culvert stone, the flow of water is not significantly impeded. It was noted that the base of the culvert was uneven, making camera progress difficult.

The officers moved to the next culvert access point, which is located within the grounds of “Railway Cottage” (red square on Map 1). This access point is larger than the first, unfortunately the lid and frame of the culvert access point was firmly stuck, and after many attempts to gain access, it remained resolutely stuck. Future access to the culvert at this point would be beneficial. It was also noted, the assumed route of the culvert passes in close proximity to a willow tree (Appendix 2 taken from Google Street View). Tree routes could further be destabilising and blocking the culvert, however, as the nearest culvert access point is sealed, it is currently not possible to prove this.

The third access point is where the watercourse briefly becomes an open channel near Grange Road and Church View (red triangle on Map 1). At this point the officers attempted

to camera survey the culvert upstream, unfortunately the camera did not progress far due to the flow of the watercourse and the extremely uneven base of the culvert.

The officers then went back to the inspection point on Grange Lane (red circle on Map 1) and carried out a dye test. The dye test emerged to the east of Dacre Banks, in an open channel (red star on Map 1) after a prolonged period. This is an indication that the culvert does have a flow to it, however, it was fairly slow. The officers also noticed that the condition of the watercourse at this point was in a state of disrepair and required maintenance. This may also be limiting onward flows of the watercourse and should be maintained by the riparian owner.

Gaining access to the culvert at the access point within Railway Cottage grounds would be beneficial to further understanding the state of the culvert.
